# HURRICANE KATE STORM SURGE DATA

## Report 5

Andrew W. Garcia, William S. Hegge

Coastal Engineering Research Center

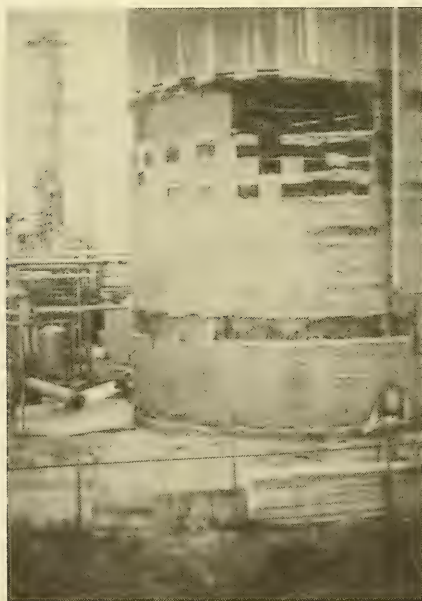
15. The extent of wind damage increased rapidly farther east; an example can be seen by the stripped siding and insulation on a storage tank at the paper company in Port St. Joe (Photo 4). However, the amount of surge damage in Port St. Joe was minimal due to the excellent protection offered by the St. Joseph spit offshore. The spit itself suffered massive erosion, as can be seen by the scarp cut into the duneline at the St. Joseph Peninsula State Park (Photo 5). The combined surge and wave runup at this location exceeded +16 ft.

Photo 4. Damaged tank covering, Port  
St. Joe, Fla.

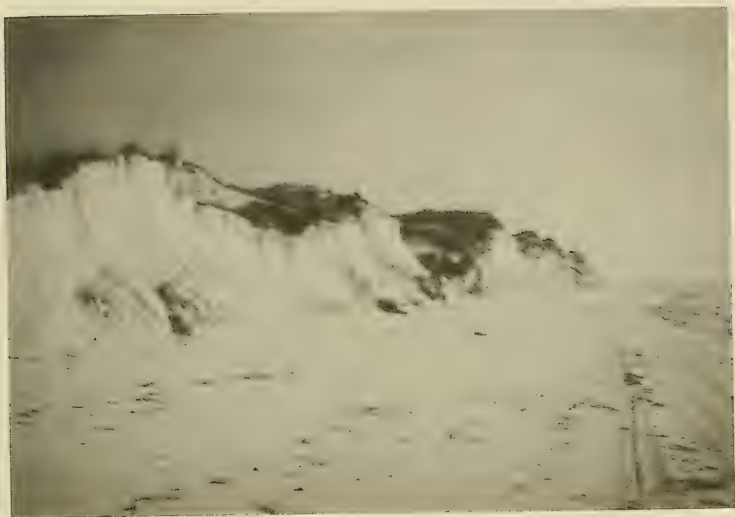
Photo 5. Beach erosion, St. Joseph Peninsula State  
Park, Fla.

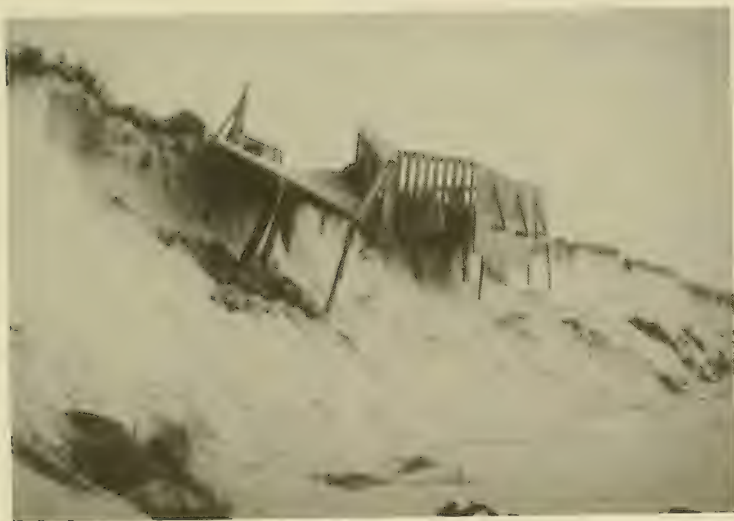
16. Property damage within the park was confined to boardwalks (Photo 6) due to the lack of construction along the beachfront. Farther south at Cape San Blas, there was more extensive damage. Several homes were totally destroyed (Photo 7), and houses that survived were undermined by beach erosion (Photo 8). The surge elevation at this location was approximately at 9 ft. Many of the buildings located far enough from the beach to be protected from surge damage suffered wind damage (Photo 9).

Photo 6. Damaged boardwalk, St. Joseph Peninsula State  
Park, Fla.

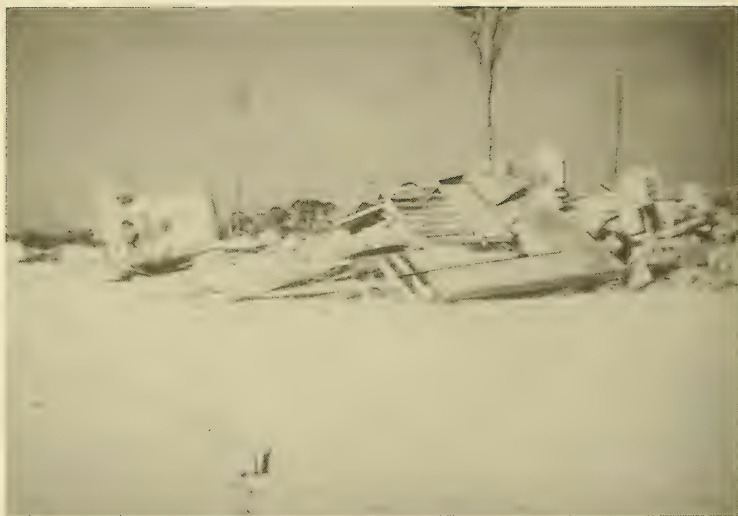
Photo 7. Destroyed house, Cape San Blas, Fla.

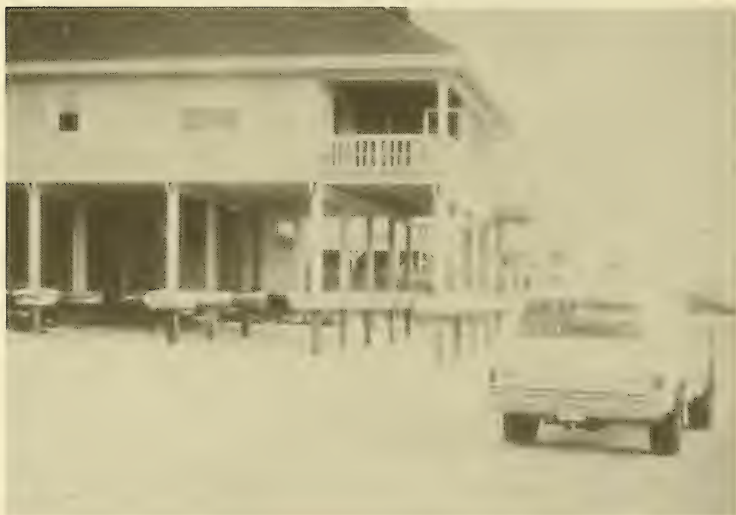
Photo 8. Beach erosion under house, Cape San Blas, Fla.

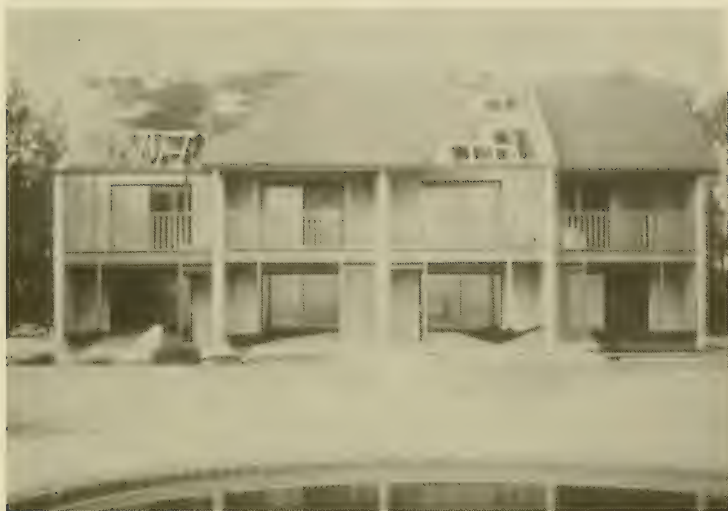
Photo 9. Roof damage, Cape San Blas, Fla.

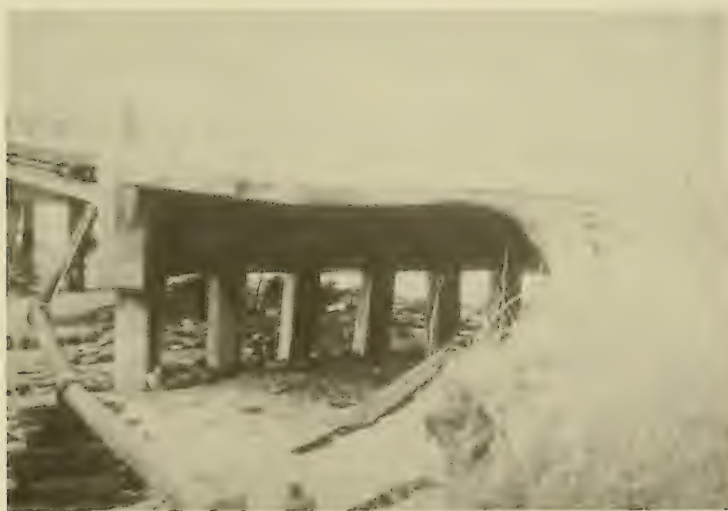
bridge to the island, cutting off all vehicular access (Photo 10). Damage was significant on the protected mainland coast behind the island. Several miles of Highway 98 along the coast between Cape San Blas and Carrabelle were undermined and had collapsed (Photos 11 and 12). The Hut Restaurant in Apalachicola was completely destroyed (Photo 13). Between East Point and Carrabelle, several homes and trailers located on waterfront lots were totally destroyed (Photos 14 and 15). Farther east, at Lighthouse Point, there was more destruction (Photo 16). Throughout this area, surge elevations were approximately 7 ft. Wind and surge damage, although less severe, was reported as far east as Cedar Key, Fla.

Photo 10. Highway damage, St. George Island Bridge, Fla.

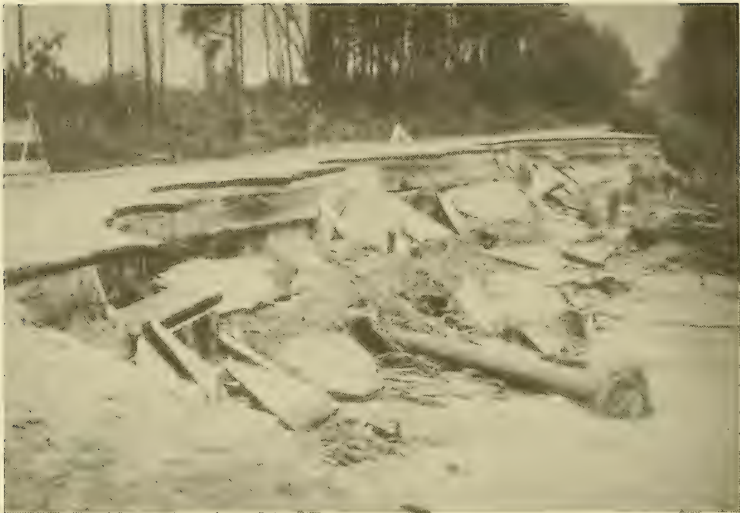
Photo 11. Highway damage between Cape San Blas and Carrabelle, Fla.

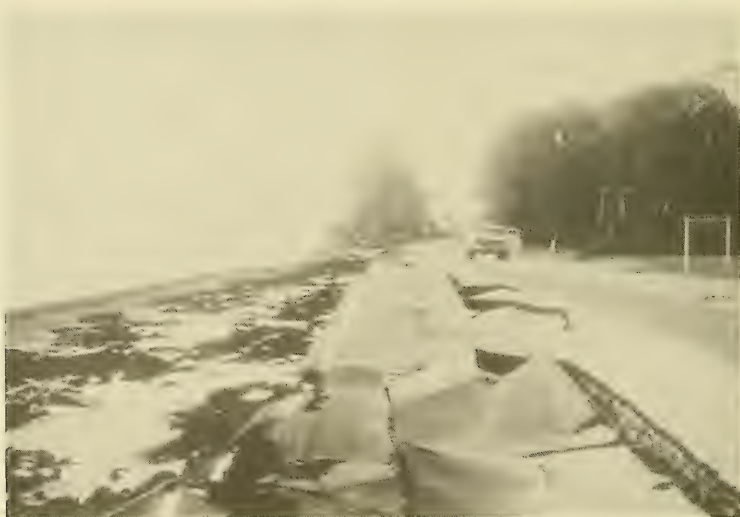
Photo 12. Highway damage near Carrabelle, Fla.

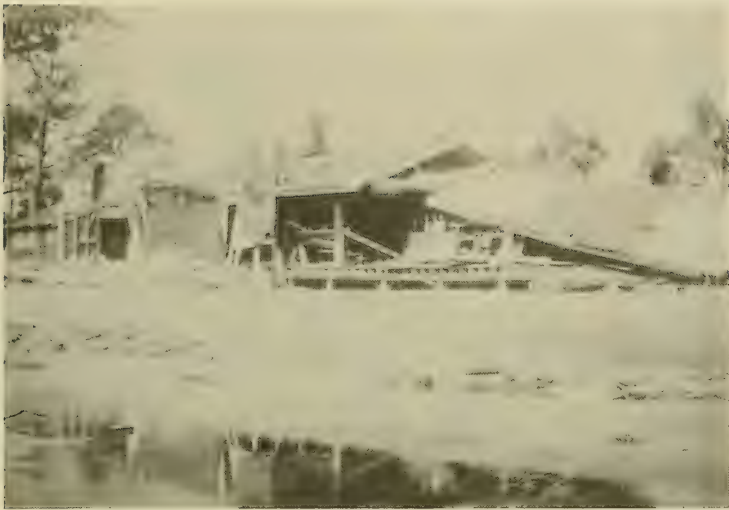
Photo 13. Building destruction, Apalachicola, Fla.
